Kiwi Feather Props Ltd – LIMITED WARRANTY

K4 - CUSTOMER MANUAL

VERSION: 11.01.2021

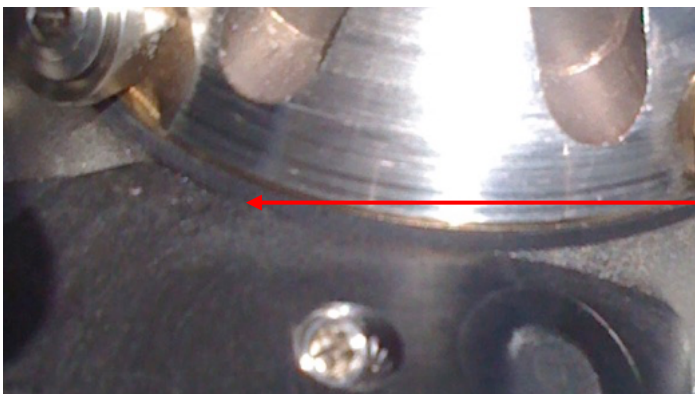
This photo shows the rear of the blade aligned with the front of the aft seal which will equate to ~ 20 ° of pitch.

Increasing the pitch by screwing the pitch screw IN to align the blade surface with the rear edge of the seal will equate to ~ 23 °

One turn of the 8 mm pitch screw in a clockwise direction to each blade in turn will equate to 3 degrees of pitch [not inches of pitch] and substantially increase the power required from the engine and drive train. This will translate to lower engine revs. We would recommend adjustments be made in no more than exact half turn increments to each blade, which has the effect of varying engine revs by some 200 ~ 300 rpm. Each installation is unique and only experience can deliver the appropriate settings and optimal cruising revs for your vessel. A pitch setting of 21 degrees on a 17" unit typically equates to a normal pitch of ~ 11 to 12 inches. [The required Allen key is 5/32" or 4 mm]
